Final Report on the SRB Frustrum "Smiley" Cracking Phenomenon Study

February 6, 1993

Thomas A. Cruse, Ph.D.
401 Bowling Ave. #6
Nashville, TN 37205
(615) 343-8727; (615) 343-8730 (fax)

SRB Frustrum "Smiley" Cracking Phenomenon Study

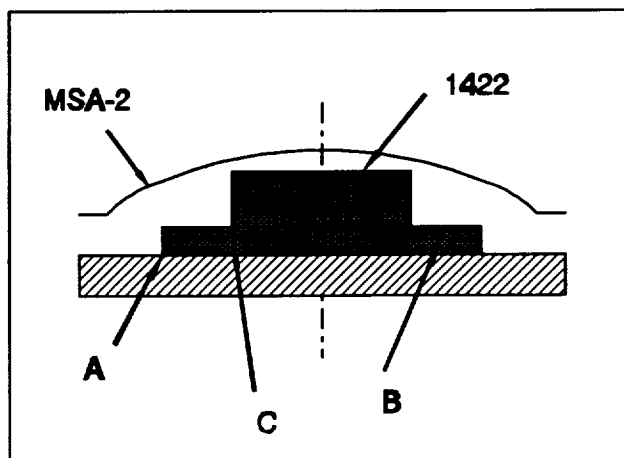
Figure 1: Representation of Material Configuration at Single Fastener

The figure indicates the essential features of the material arrangement in the area of a single fastener. Examination of all of the removed specimens containing various sizes, shapes, and orientations of cracks including the specimen with the divot indicated that each appeared to have common elements which are seen to be critical to understanding the "smiley" problem. Locations A, B, and C are all locations of an appearance of weak bonding between the MSA and substrate materials. Locations B and C have 1422 sealant as the substrate, while location A has base metal as the substrate material. Location C is the site of the undercut associated with the caps that are used for sealant application. The sealant between sites A and C is the overfill sealant from the application procedure and has variable thickness. In one case, the 1422 sealant was seen to extend beyond site A on the metal substrate but with very little apparent thickness. It would seem that the cleanup of the overfill resulted in a regularly-sized "smear" of 1422.

very low strength of the bond at site B in the figure, corresponding to the MSA-2 bond on the overfill bead of the 1422 sealant. The very low strength conclusion is based on the lack of adhesion of the MSA-2 to the 1422 indicated by MSA-2 "fuzz" which is clearly seen on other locations of the debond. Examination of the witness surface on the MSA-2 material I removed showed a consistent picture - the MSA-2 surface at location B was quite smooth and had the appearance of a mold of the 1422 sealant.

Examination of the six debonded regions also shows that the adherence of MSA-2 to the supporting material is weak at locations A and C. In no case did the weak bond of MSA-2 to base metal extend more than a few mils from the edge of the 1422, but the metal surface clearly showed a lack of retained MSA-2 over a significant arc length of the failed zone. The radial extent of the weak bond is consistent with the size of the "voids" noted in the report on STS-48 that I read. The MSA-2 fractures were all featured as conical failure surfaces at roughly 45° to the substrate. The small radial extent of the weak bonded surface indicated to me that this location was not primary, but secondary in the sequence of MSA-2 fracture.

The weak bond of MSA-2 and 1422 sealant is radially large compared to that at location A. The weakness may include both locations B and C. The undercut showed very little likelihood of good bonding between the two materials. However, the size of the weak region associated with the overfill surface (location B) appears to be large enough to allow fracture associated with the depressurization event near the point of separation, when the external pressure at the hypalon is at its lowest point. Such depressurization fractures of the MSA-2 material were shown in the USBI M&P test report, without the need for external heating. In removing the MSA-2 material from the selected sites, I qualitatively noted that the bond to the crown of the 1422 sealant in cases where the debond did not include this region, was quite strong in comparison to that strength I noted in peeling the material from location B.

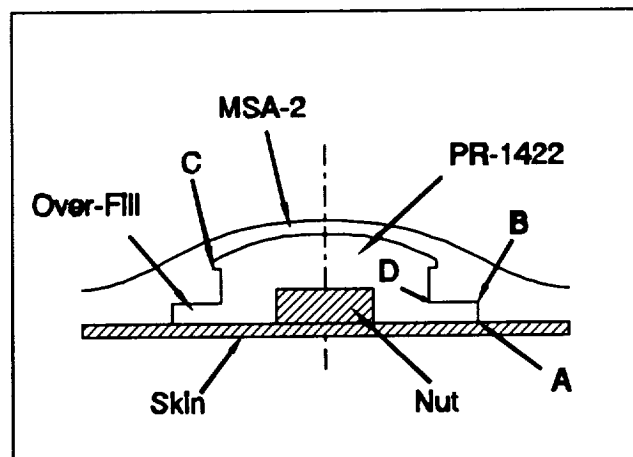
Figure 4: Schematic Showing Key Locations

The results of the stress analyses for all cases involving excess PR-1422 material show that the maximum effective stress occurs at location B, as indicated in Figure 4. The mechanical cause of the high stress at this location is the re-entrant corner formed by the MSA-2, and the fact that the MSA-2 material is much stiffer than the PR-1422 material. The load being carried by the MSA-2 material over the PR-1422 sealant must turn the corner at location B, and then flow to the substrate at location A. The high stress region focused at point B extends into the MSA-2 material, somewhat along the interface towards location A. Stress contour results for the various cases are given in the appendices to this report. The maximum stresses are not to be taken too literally, as they will increase as the size of the finite elements near location D is refined. All FEM model results are based on the same mesh refinement near the stress concentrations, in order to make the comparisons, at least, meaningful. The following table summarized the results for the FEM solutions involving geometries with excess PR-1422 material, shown above as the overfill region.

The FEM analysis therefore strongly suggests that the excess material should act to reduce the strength of the MSA-2/PR-1422 bond. Further, failure should occur from locations near the corner of the excess PR-1422 material (location B). The strength reduction due to the stress concentration is of the order of 30%, based on these results.

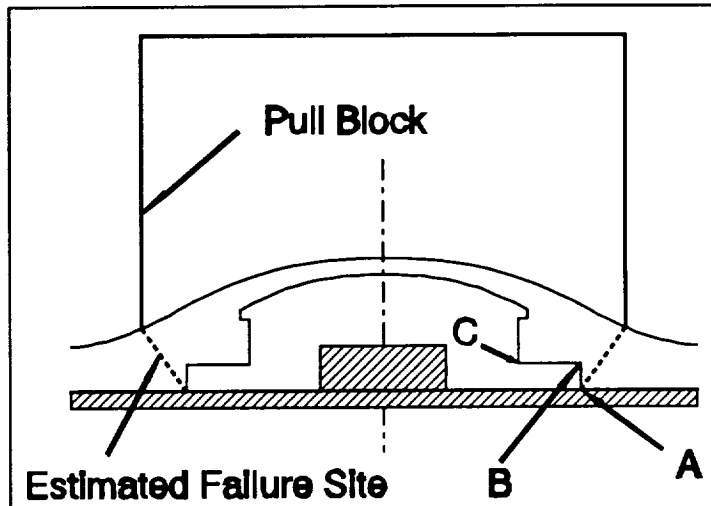
Figure 6: Schematic of Local Failure Region and Test Block

It was anticipated that failure of the locations with overfill will initiate at location B. Disbond will extend from B to locations A and C and beyond C toward the centerline, along the material interface. It was not known how suddenly the disbond along this path will be. At this time, I assume that the bond will remain intact up to some critical load level at which the disbond occurs. Following disbond, the load deflection curve is likely to be more compliant, indicating that there is softer support for resisting the pull bar. The break point is indicated in Figure 6 as point B. Final failure will likely occur as a separation along the path indicated as the estimated failure site.

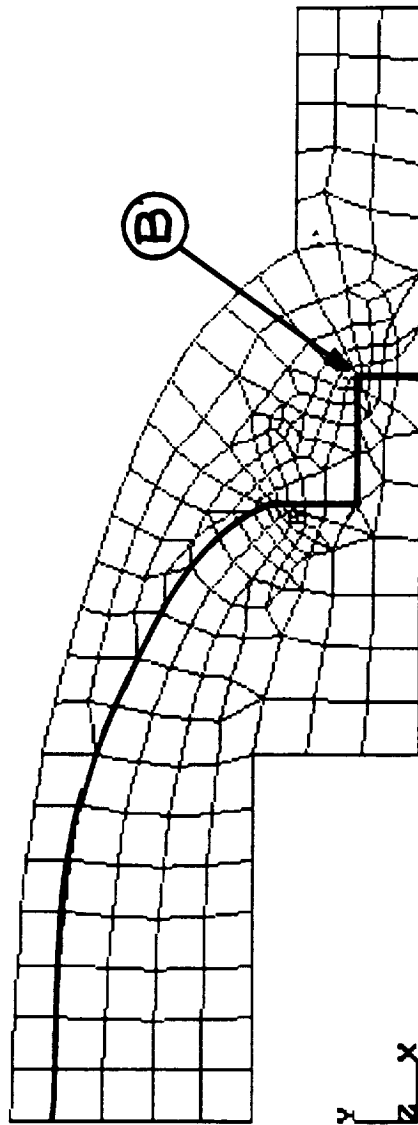
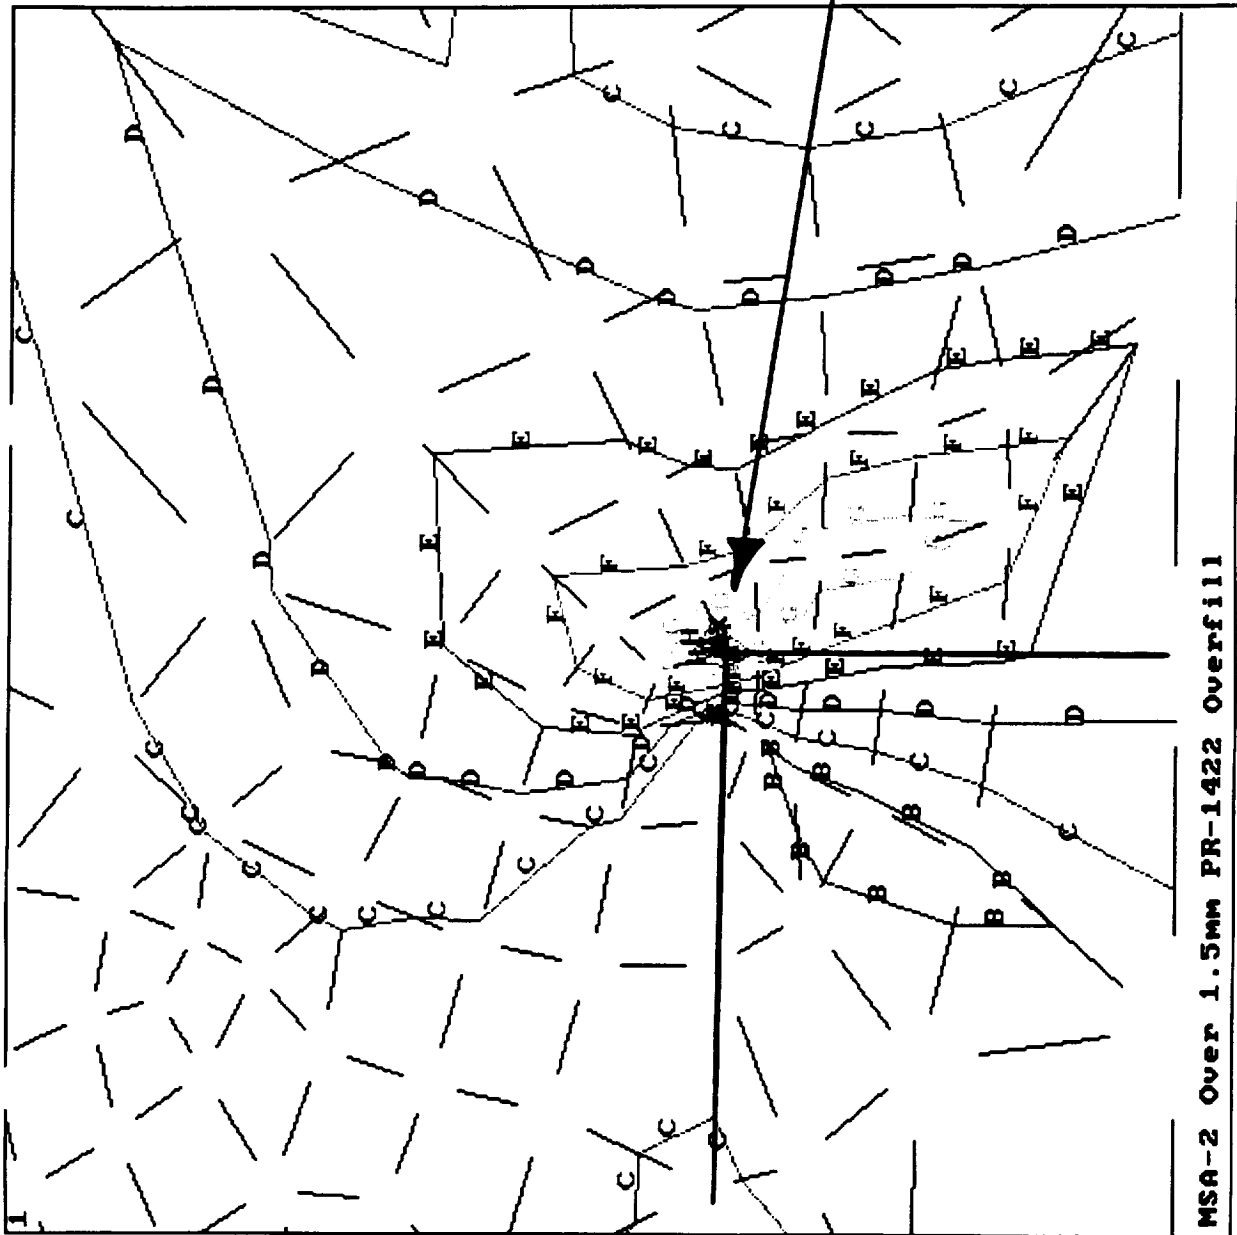
CASE 5

MSA-2 Over 1.5mm PR-1422 Overfill

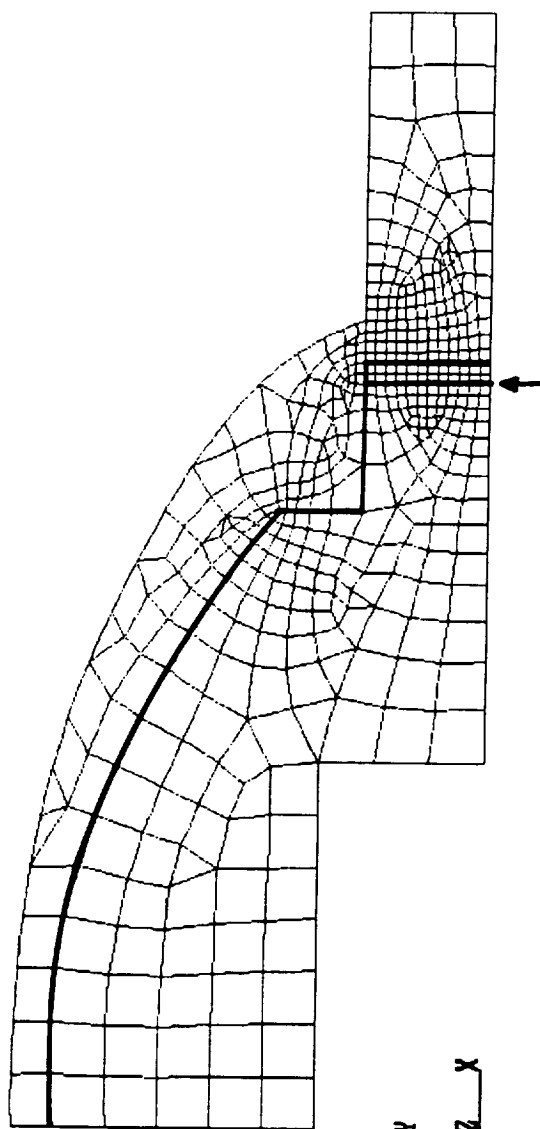
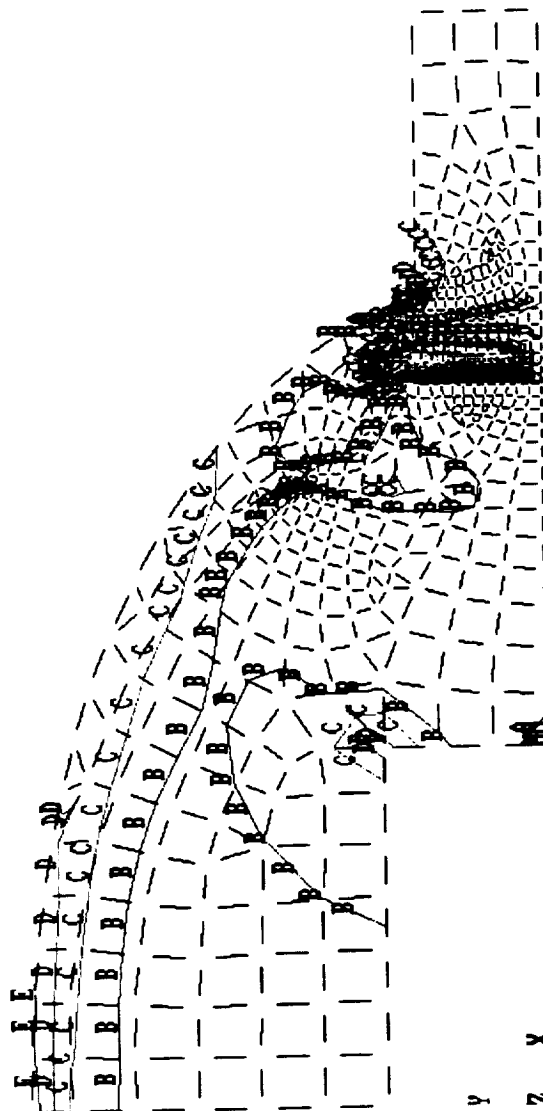
CASE - Y

Reduced MSA-2 thickness over excess PR-1422
